# 2014 MITSUBISHI PAJERO GLS HIGHLINE | 189,288 KM

VIN: JMYLYV97WEJ705997

## **150 Point Detailed Inspection Report**

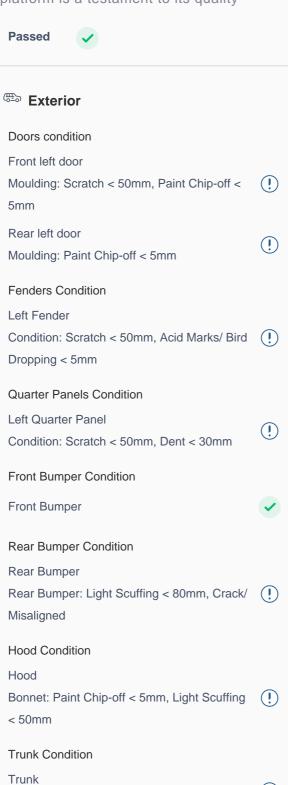
Door Trim: Light Scuffing < 50mm

Front right door Moulding: Light Scuffing < 50mm, Paint Chipoff < 5mm Rear right door (!)Moulding: Paint Chip-off < 5mm Right Fender Right Fender: Scratch < 50mm, Paint Chip-off (!) < 5mm Right Quarter Panel (!)Condition: Scratch < 50mm

Left A Pillar	<b>✓</b>	Right A Pillar	<b>✓</b>
Left A to B Pillar Beading	<b>✓</b>	Right A to B Pillar Beading	<b>✓</b>
Right A to B Pillar Light Scuffing < 50mm	(!)	Left B Pillar	<b>✓</b>
Left B Pillar Trim Light Scuffing	!	Left B to C Pillar Beading	<b>✓</b>
Right C Pillar Trim	<b>✓</b>	Right B to C Pillar  Light Scuffing < 80mm	(!)
Right B to C Pillar Beading	<b>✓</b>	Left C Pillar Scratch < 50mm	(!)
Running Board Condition  Left Running Board  Front Left Floor Trim: Light Scuffing < 80mm  Sunroof Glass Condition (If Equipped)	!	Right Running Board Front Right Floor Trim: Light Scuffing < 80mm	(!)
Sun Roof Glass	<b>✓</b>		
Windshield Condition Front Windshield Condition: Driver Side/Stone Chip Mark<5mm, Passenger Side/Stone Chip Mark<8mm	!	Rear Windshield	<b>✓</b>
Structural Assessment			
Chassis Condition	<b>✓</b>	Radiator Support	<b>✓</b>
Apron	<b>✓</b>	Boot Floor  Door Skirting: Low Visual Dent < 30mm, Light  Scuffing < 50mm, Paint Chip-off < 5mm	!

Firewall Condition	•	Cowl Top Beading: Crack/Fair Use Wear<50mm	(!)
Head Light Support Condition	<b>✓</b>		
Cowl Top			
Cowl Top	<b>✓</b>		
Rear View Mirror Condition  Left Hand Side Mirror  Body: Paint Chip-off < 5mm	!	Left Side Mirror	<b>✓</b>
Right Side Mirror	<b>✓</b>	Right Hand Side Mirror	<b>✓</b>
Alloy Wheel/ Rim

Left Front Alloy/ Rim	<b>✓</b>	Rim: Alloy Edge/ Scuff < 80mm	!
Right Front Alloy/ Rim	!	Right Rear Alloy/ Rim	(!)
Rim: Alloy Edge/ Scuff < 80mm		Rim: Alloy Edge/ Scuff < 80mm	
Spare Alloy/ Rim Condition	•		
Wheel cover	<b>✓</b>	Antenna	<b>✓</b>
Grill Condition Light Scuffing < 50mm	(!)	Monogram Chrome Low Brightness/ Fair Use Wear	!
Window Glass	<b>✓</b>	Wiper	<b>✓</b>
Panel Condition			
Rear Trunk Panel Scratch < 50mm	!		
<b>■ Engine &amp; Transmission</b>			
Engine			
Engine Body	<b>✓</b>	Engine Performance	<b>✓</b>
Engine Oil (Condition & Level)	<b>✓</b>	Exhaust System	<b>✓</b>
Radiator Condition	<b>✓</b>	Radiator Coolant	•
Battery			
Battery Terminal & Tightness	<b>✓</b>		
Fuel System			
Fuel Tank	<b>✓</b>		
Transmission Operation			
Gear Shifting	<b>✓</b>	Drive Axle	<b>✓</b>
4*4 Condition (If Applicable)	<b>✓</b>	Transmission Fluid	<b>✓</b>
Steering, Suspension & Brakes			
Steering			
Steering wheel	<b>✓</b>

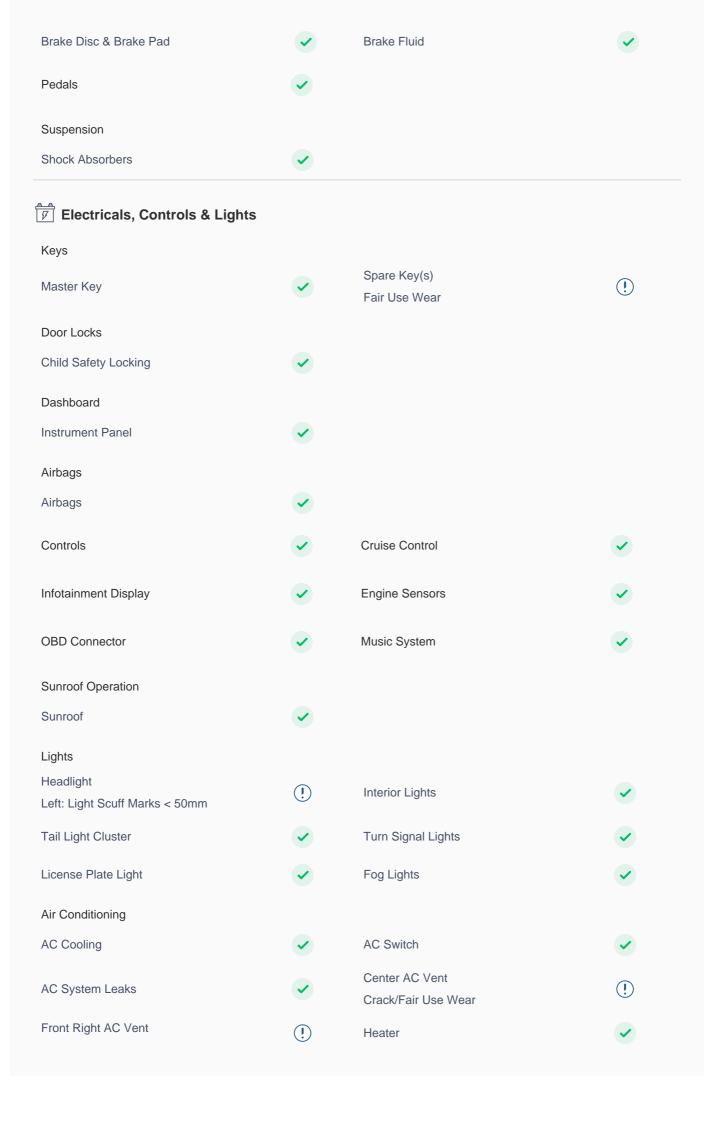
Crack/Fair Use Wear			
Rear Left AC Vent RHS Crack/Fair Use Wear	!		
Parking Sensors	<b>✓</b>	Rear Defogger Extensive Wear Of Strip	!
USB Charging Port	•	Power/ Manual Windows Front Left: Master Switch Buttons Faded	!
🖺 Interiors & Luggage			
Dashboard And Instrument Panel  Dashboard And Instrument Panel: Light  Scuffing/Crack	(!)	Central Console  Arm Rest: Minor Disfiguration	(!)
Cup Holder	<b>✓</b>	Glove Box Glove Box: Glove Box Retainer Faulty, Minor Scuffing/Crack/Fair Use Wear	!
Steering Wheel Steering Wheel Fair Use Wear	!	Sunvisor	<b>✓</b>
Seat Upholstery Driver Seat: Minor Leather/ Fabric Fair Use Wear/ Tears, Minor Fair Wear/Fade off, Minor Smudge/ Cracks	(!)	Manual Seat Movement	<b>✓</b>
Seat Belts	<b>✓</b>	Head Rest	<b>✓</b>
Door Controls And Trim Front Left Door: Scuffing, Scuffing/ Disfiguration	(!)	Grab Handle	•
Carpet Front Left Floor Mat: Smudge/Burn/Crack	(!)	Headliner Front Left: Crack/Fair Use Wear, Light Smudge/Disfiguration	!

LHS Front Tyre	<85%	LHS Rear Tyre	<90%
RHS Front Tyre	<75%	RHS Rear Tyre	<75%
Spare Tyre	<75%
