# 2015 HYUNDAI TUCSON GL | 109,724 KM

VIN: KMHJT81C5FU961855

### **150 Point Detailed Inspection Report**

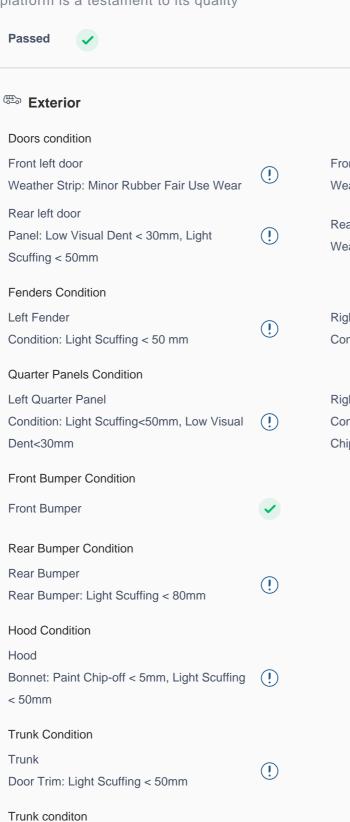
Front right door (!) Weather Strip: Minor Rubber Fare Use Wear Rear right door (!)Weather Strip: Minor Fair Use Rubber Wear Right Fender (!)Condition: Light Scuffing < 50mm Right Quarter Panel Condition: Low Visual Dent < 30mm, Chip>5mm

## **Pillars Condition** Left A Pillar Right A Pillar Left A to B Pillar Beading Right A to B Pillar Beading Left B Pillar Right A to B Pillar Condition: Light Scuffing Scratch < 50mm Left B Pillar Trim Left B to C Pillar Beading Right C Pillar Trim Right B to C Pillar Left C Pillar Right B to C Pillar Beading Low Visual Dent < 30mm **Running Board Condition** Left Running Board Right Running Board Front Right Floor Trim: Light Scuffing < 80mm Rear Left Sill Trim: Light Scuffing < 80mm Windshield Condition Front Windshield Rear Windshield Structural Assessment **Chassis Condition** Radiator Support **Boot Floor** Apron Door Skirting: Colour Mismatch/ Fade/ Fair Use Wear Firewall Condition Cowl Top Head Light Support Condition Cowl Top Cowl Top Rear View Mirror Condition Left Hand Side Mirror Left Side Mirror Right Side Mirror Right Hand Side Mirror **Body: Paint Defects** Alloy Wheel/ Rim Left Front Alloy/ Rim Left Rear Alloy/ Rim Right Front Alloy/ Rim Right Rear Alloy/ Rim Rim: Alloy Edge Scuffing < 80mm Spare Alloy/ Rim Condition
