2015 RENAULT KOLEOS SE | 91,407 KM

VIN: VF1VYRCEXFC511540

150 Point Detailed Inspection Report

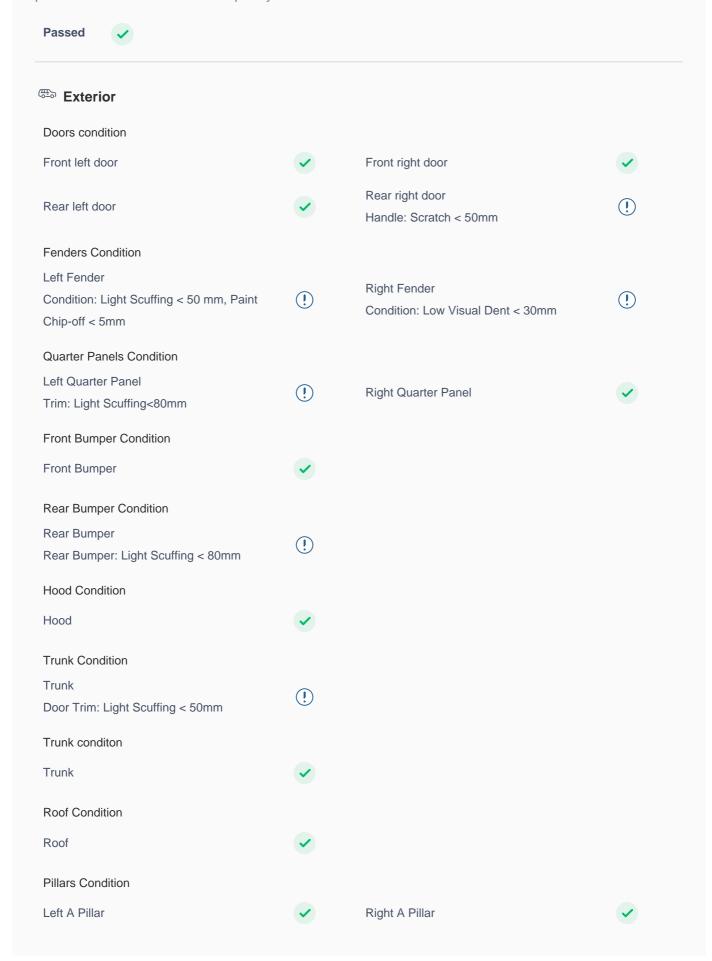
Left A to B Pillar Beading	✓	Right A to B Pillar Beading	✓
Right A to B Pillar	✓	Left B Pillar	✓
Left B Pillar Trim	✓	Left B to C Pillar Beading Beading Crack/ Tear < 5mm	(!)
Right C Pillar Trim	✓	Right B to C Pillar	~
Right B to C Pillar Beading	✓	Left C Pillar Scratch < 50mm	(!)
Running Board Condition			
Left Running Board Condition: Scratch < 80mm	!	Right Running Board Front Right Sill Trim: Light Scuffing < 80mm	(!)
Windshield Condition			
Front Windshield Beading: Mouldings Crack/ Fair Use Wear < 50mm	!	Rear Windshield Tint Fair Use Wear < 30mm	!
Structural Assessment			
Chassis Condition	✓	Radiator Support	✓
Apron	✓	Boot Floor	✓
Firewall Condition	✓	Cowl Top Beading: Crack/Fair Use Wear<50mm	(!)
Head Light Support Condition	✓		
Cowl Top			
Cowl Top	✓		
Rear View Mirror Condition			
Left Hand Side Mirror Body: Paint Chip-off < 5mm	!	Left Side Mirror	✓
Right Side Mirror Body: Paint Chip-off < 5mm, Scratch < 50mm	!	Right Hand Side Mirror	~

Alloy Wheel/ Rim			
Left Front Alloy/ Rim	✓	Left Rear Alloy/ Rim Rim: Alloy Edge/ Scuff < 80mm	!
Right Front Alloy/ Rim	✓	Right Rear Alloy/ Rim Rim: Alloy Face/ Scuff < 50mm	(!)
Spara Alloy/ Pim Condition			
Spare Alloy/ Rim Condition	✓

Antenna	✓	Grill Condition Light Scuffing < 50mm	!
Monogram	~	Window Glass	•
Wiper	~		
Panel Condition			
Rear Trunk Panel	✓		
■ Engine & Transmission			
Engine			
Engine Body	✓	Engine Performance	✓
Engine Oil (Condition & Level)	✓	Exhaust System	✓
Radiator Condition	✓	Radiator Coolant	✓
Battery			
Battery Terminal & Tightness	✓		
Fuel System			
Fuel Tank	✓		
Transmission Operation			
Gear Shifting	✓	Drive Axle	✓
Transmission Fluid	✓		
Steering, Suspension & Brakes	3		
Steering			
Steering wheel	✓		
Brake System			
Parking Brake	✓	Brake Master Cylinder	✓
Brake Disc & Brake Pad	✓	Brake Fluid	✓
Pedals	✓		
Suspension			
Shock Absorbers	~

Electricals, Controls & Lights Keys Master Key Door Locks Child Safety Locking Dashboard Instrument Panel Odometer: minor imperfection Airbags Airbags Controls Cruise Control Infotainment Display (!) **Engine Sensors** Infotainment Display: Display Low Brightness Music System **OBD** Connector Condition: Button(s) Faded Lights Headlight (!) Interior Lights Right: Light Scuff Marks < 50mm Tail Light Cluster Turn Signal Lights Right Tail Lamp: Light Scuffing < 50mm License Plate Light Fog Lights Air Conditioning AC Switch AC Cooling Center AC Vent AC System Leaks Front Right AC Vent Heater Parking Sensors Rear Defogger **USB Charging Port** Power/ Manual Windows
