2017 HONDA ACCORD EX | 109,615 KM

150 Point Detailed Inspection Report

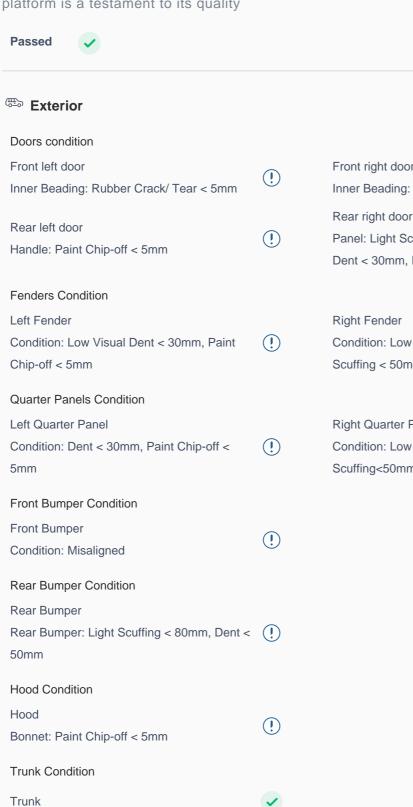
Trunk conditon

Roof Condition

Trunk

Front right door (!) Inner Beading: Rubber Crack/ Tear < 5mm Rear right door Panel: Light Scuffing < 50mm, Low Visual Dent < 30mm, Paint Chip-off < 5mm Condition: Low Visual Dent < 30mm, Light (!)Scuffing < 50mm, Paint Chip-off < 5mm Right Quarter Panel Condition: Low Visual Dent < 30mm, Light (!)Scuffing<50mm, Chip<5mm

Roof	✓		
Pillars Condition			
Left A Pillar	✓	Right A Pillar Condition: Light Scuffing<50mm	!
Left A to B Pillar Beading	✓	Right A to B Pillar Beading	✓
Right A to B Pillar	✓	Left B Pillar	✓
Left B Pillar Trim	✓	Left B to C Pillar Beading	✓
Right C Pillar Trim	✓	Right B to C Pillar	✓
Right B to C Pillar Beading	✓	Left C Pillar	✓
Running Board Condition			
Left Running Board	✓	Right Running Board	✓
Sunroof Glass Condition (If Equipped)			
Sun Roof Glass	✓		
Windshield Condition Front Windshield Beading: Mouldings Crack/ Fair Use Wear < 50mm	(!)	Rear Windshield	✓
Structural Assessment			
Chassis Condition	✓	Radiator Support	✓
Apron	✓	Boot Floor	✓
Firewall Condition	✓	Cowl Top	✓
Head Light Support Condition	✓		
Cowl Top			
Cowl Top	✓		
Rear View Mirror Condition			
Left Hand Side Mirror	✓	Left Side Mirror	✓
Right Side Mirror Body: Scratch < 50mm	!	Right Hand Side Mirror	✓
Alloy Wheel/ Rim			
Left Front Alloy/ Rim	•	Left Rear Alloy/ Rim Alloy Wheel: Rust Damage	(!)

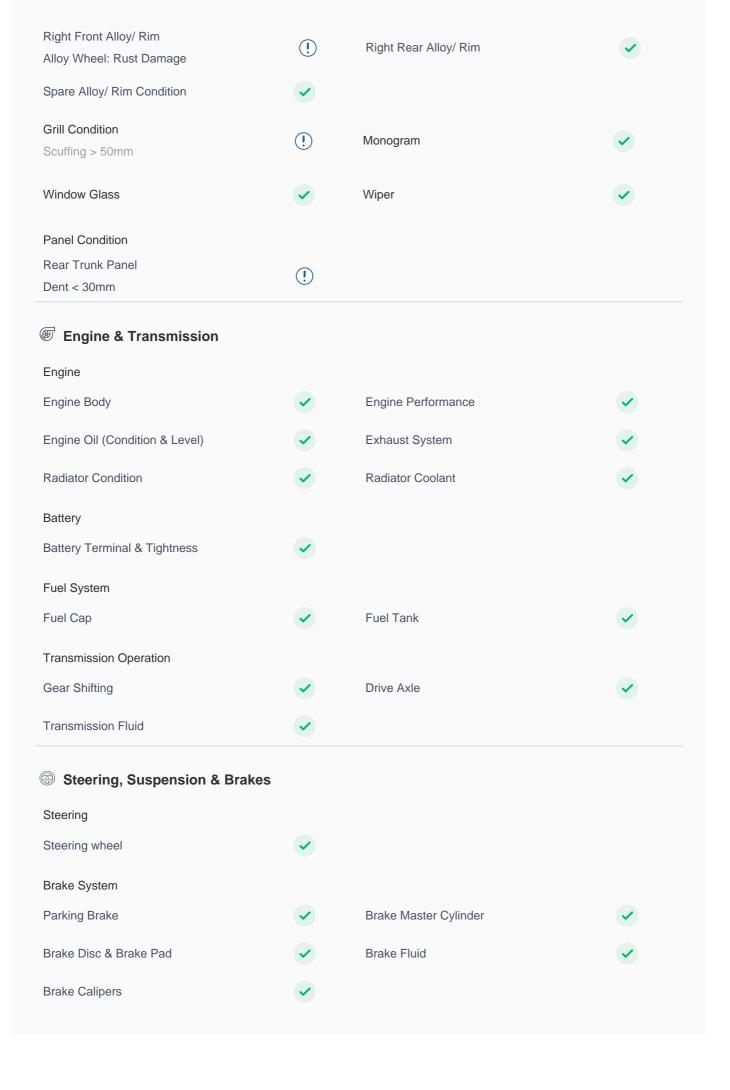
Pedals	~		
Suspension			
Shock Absorbers	✓		
Electricals, Controls & Lights			
Keys			
Master Key	✓	Spare Key(s)	✓
Door Locks			
Child Safety Locking	✓		
Dashboard			
Instrument Panel Odometer: Stain	(!)		
Airbags			
Airbags	✓		
Controls	✓	Cruise Control	•
Infotainment Display	✓	Engine Sensors	✓
OBD Connector	•	Music System	✓
Sunroof Operation			
Sunroof	✓		
Lights			
Headlight Left: Scratch	(!)	Interior Lights	✓
Tail Light Cluster Right Tail Lamp: Light Scuffing < 50mm	(!)	Turn Signal Lights	✓
Daylight Running Lights	✓	License Plate Light	✓
Fog Lights	✓		
Air Conditioning			
AC Air Direction Switch	✓	AC Cooling	✓
AC Switch	✓	AC System Leaks	✓
Center AC Vent	✓	Front Right AC Vent	✓

Heater	~	Rear Blower Switch	✓
Parking Sensors	✓	Rear Defogger	✓
USB Charging Port	✓	Power/ Manual Windows	•
∄ Interiors & Luggage			
Dashboard And Instrument Panel Dashboard Upholstery: Colour Faded, Scratch < 50mm, Crack/ Damage < 10mm	(!)	Central Console Gear Shift Knob: Buttons Faded	(!)
Cup Holder	✓	Glove Box: Scratch	(!)
Steering Wheel Colour Fade	!	Sunvisor	•
Seat Upholstery Driver Seat: Stain < 50mm	!	Manual Seat Movement	•
Seat Belts	✓	Head Rest	•
Door Controls And Trim	✓	Grab Handle	✓
Carpet Front Left Floor Mat: Crack & Tear > 30mm	!	Headliner	•
Rear View Mirror	✓	Toolkit	•
Tyres			
Tyres Condition			
Left Hand Side Front Tyre	✓	Left Hand Side Rear Tyre	✓
Right Hand Side Front Tyre	✓	Right Hand Side Rear Tyre	✓
Spare Tyre	✓		
Tyres Depth (Remaining)			
LHS Front Tyre	<65%	LHS Rear Tyre	<65%
RHS Front Tyre	<65%	RHS Rear Tyre	<75%
Spare Tyre	<85%
